2017 Application for Bridge Funding

PICKARD AVENUE BRIDGE OVER THE CHIPPEWA RIVER

City of Mount Pleasant, Isabella County

Submitted by:
City of Mount Pleasant
April 2014

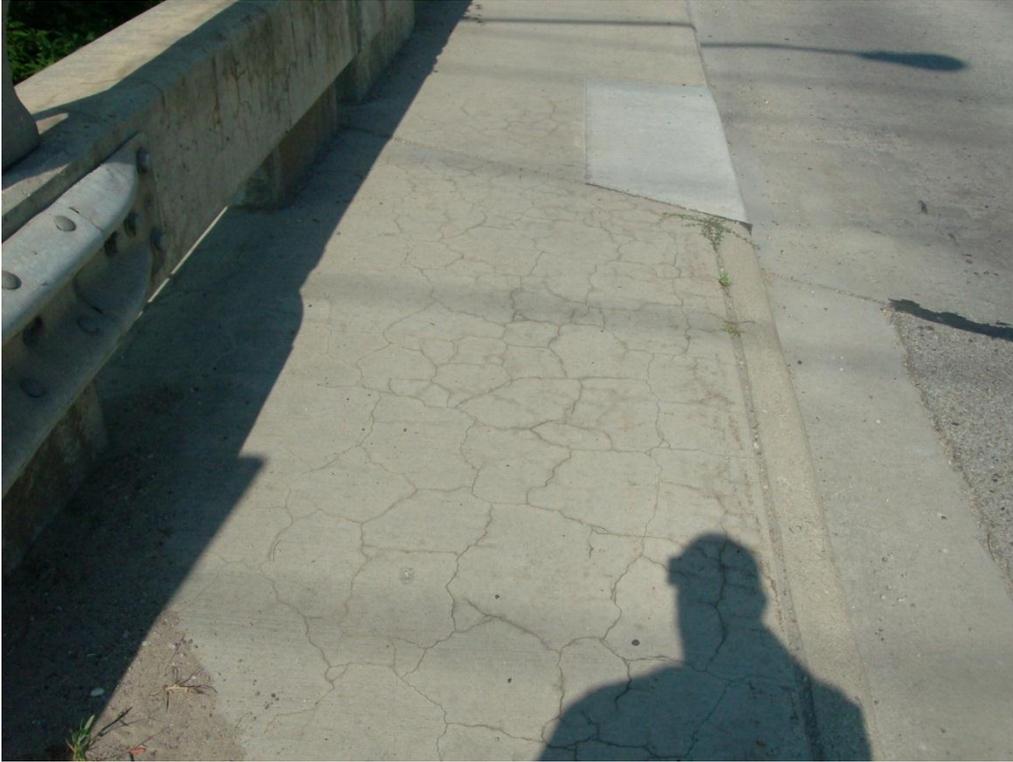
| 5. Sidewalks or curbs | 3 | 3 | 3 | Concrete sidewalks. Approximately 10 to 15% of sidewalk area has been previously repaired. More than 50% of remaining sidewalk area is delaminated based on sounding. Monitor sidewalks. They will be spalling soon. (12) Concrete sidewalks. Approximately 10 to 15% of sidewalk area has been previously repaired. More than 50% of remaining sidewalk area is delaminated based on sounding. Monitor sidewalks. They will be spalling soon. (10) 2 more areas patched from the last inspection. There is a 2' by 2' area in the SE quadrant that is failing. area has spalled and appears to have deteriorated to a gravel state. (08) |

Delaminated/map cracked sidewalk

| CREW RECOMMENDATIONS | | | CONTRACT RECOMMENDATIONS | | |
|---|---|--|---|---|---|
| Joint Repair | H | Seal Expansion joints | Deck Replacement | M | Due to ASR, deck and sidewalk should be replaced. Verify load rating prior to applying for funding. |

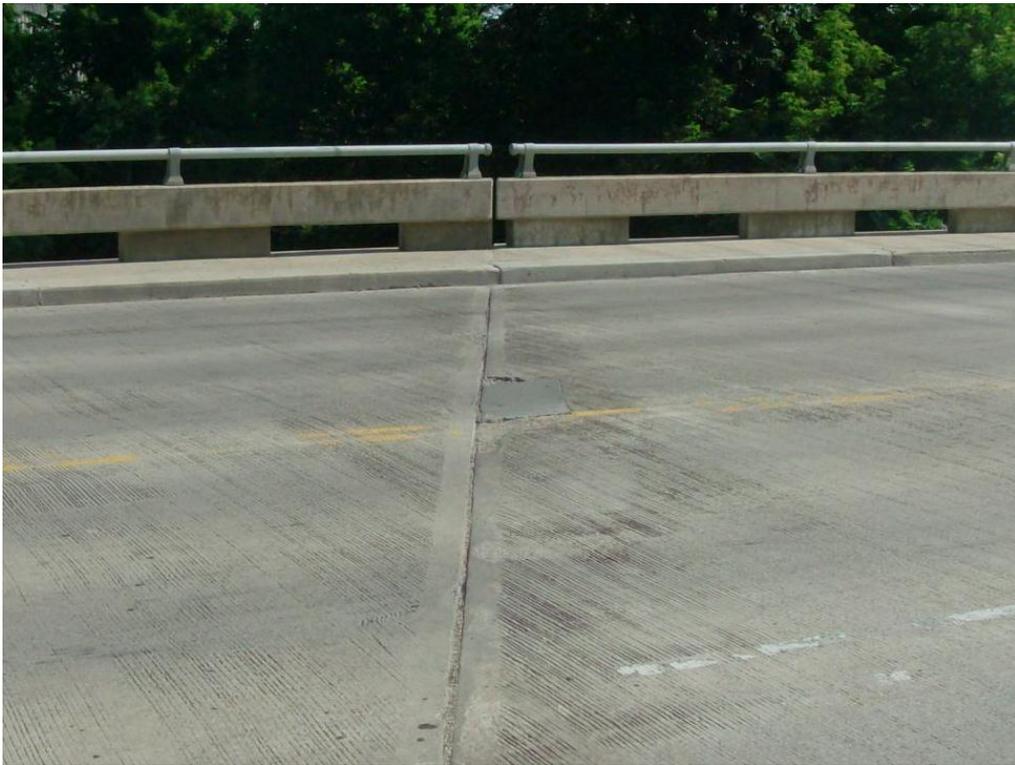
Patchwork on Bridge Deck

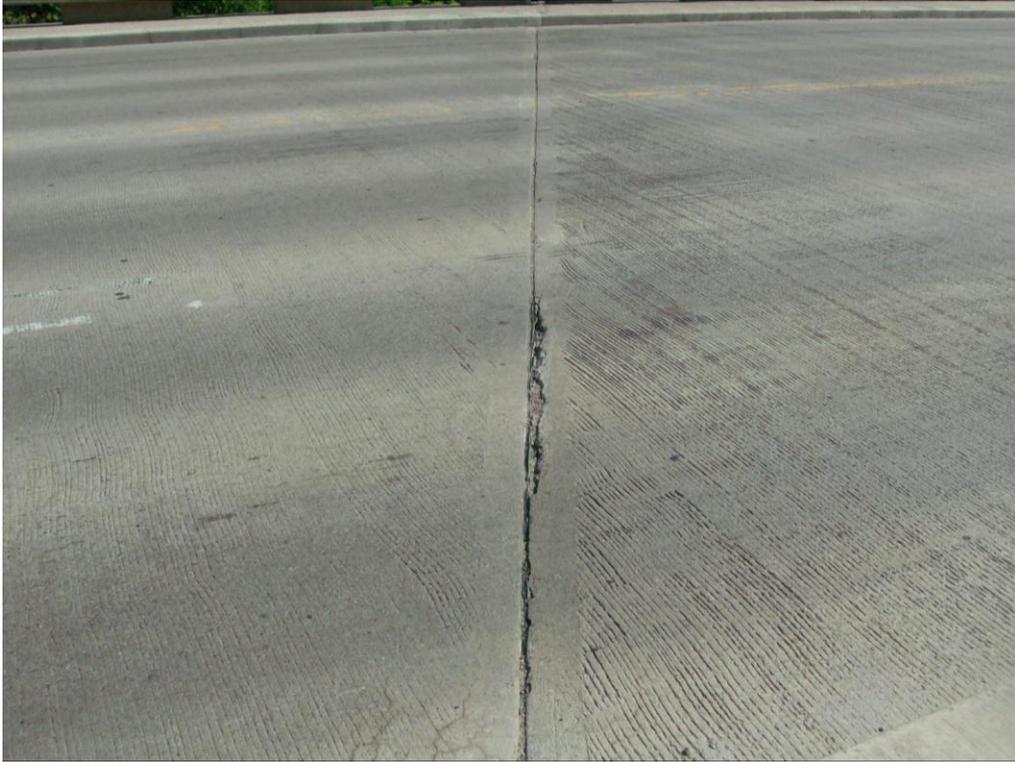
| 1. Surface SIA-58A | 5 | 5 | 5 | Concrete deck. Some delamination on < 2% of deck. Hairline longitudinal beam cracks w/ random transverse cracking. (12) Concrete deck. Hairline longitudinal beam cracks w/ random transverse cracking. (10) Hairline longitudinal beam cracks w/ random transverse cracking. (08) |

Spalling on Bridge Deck

| CREW RECOMMENDATIONS | | | CONTRACT RECOMMENDATIONS | | |
|---|---|--|---|---|---|
| Deck Patching | M | Hand chip delaminated areas and patch | Bridge Replacement | | |

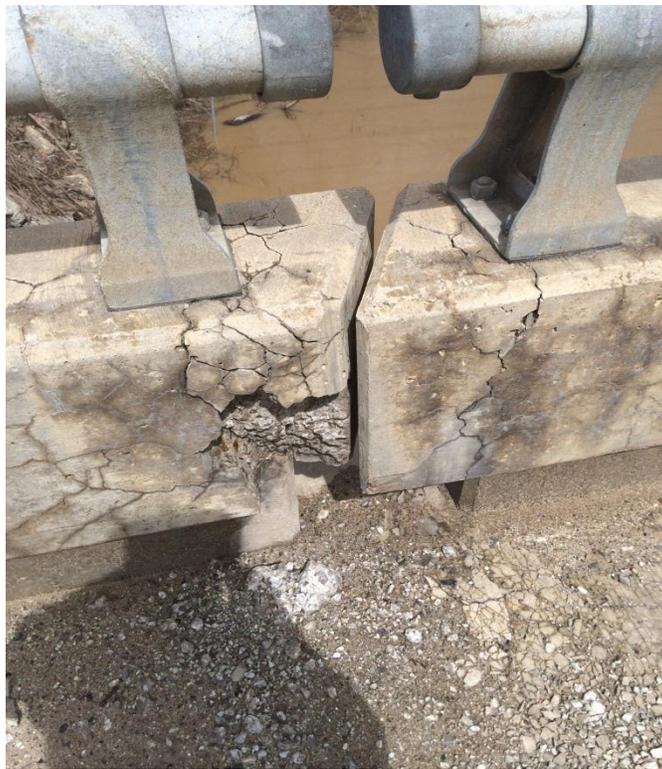
| 4. Railings | 6 | 5 | 5 | Concrete open parapet rail with metal tube above. Concrete has map cracking throughout. Half of the end blocks are spalling with rust and/or frost expanding and breaking them apart. This is a small area based on surface area, but major delamination. Approach rail is in place in all but the NW quadrant. (12) Concrete Open Parapet Rail with metal tube above. Concrete has map cracking throughout. Half of the end blocks are spalling with rust and/or frost expanding and breaking them apart. This is a small area based on surface area, but major deterioration. Approach rail is in place in all but the NW quadrant. (10) Map cracking throughout railings. Sounding does not indicate delamination. (08) |

Spalls and cracks at ends of rails

| CREW RECOMMENDATIONS | | | CONTRACT RECOMMENDATIONS | | |
|---|---|--|---|---|---|
| Railing Repair | L | Monitor railing for ASR failure. Sidewalk replacement may impact railing | Overlay | | |

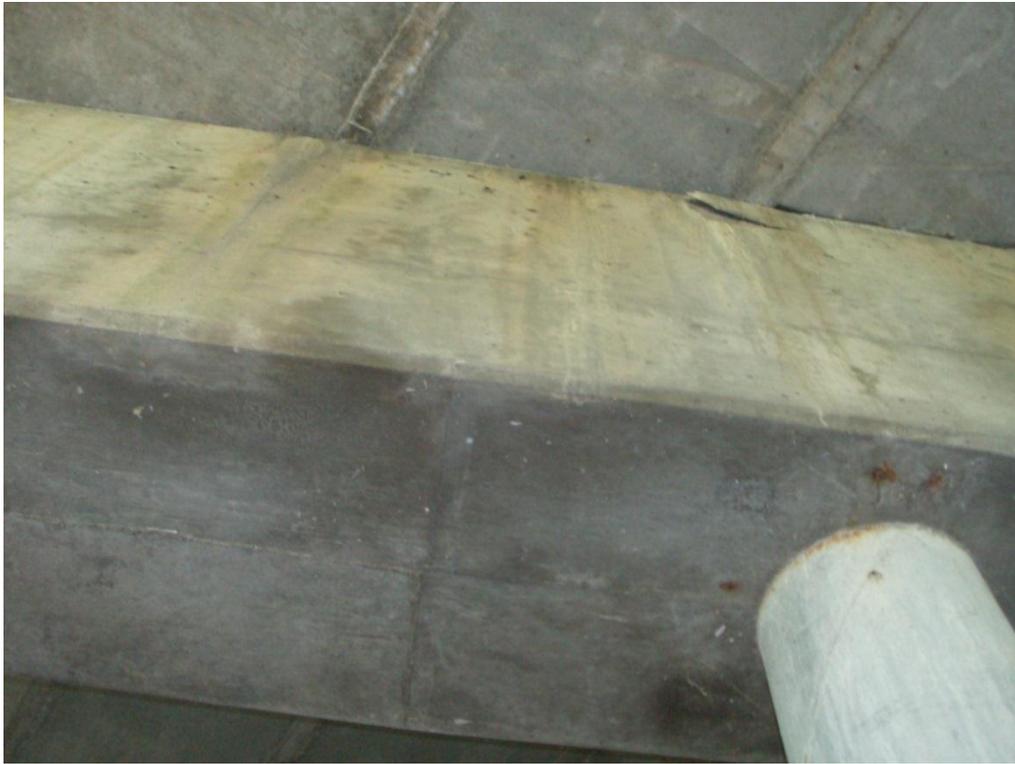
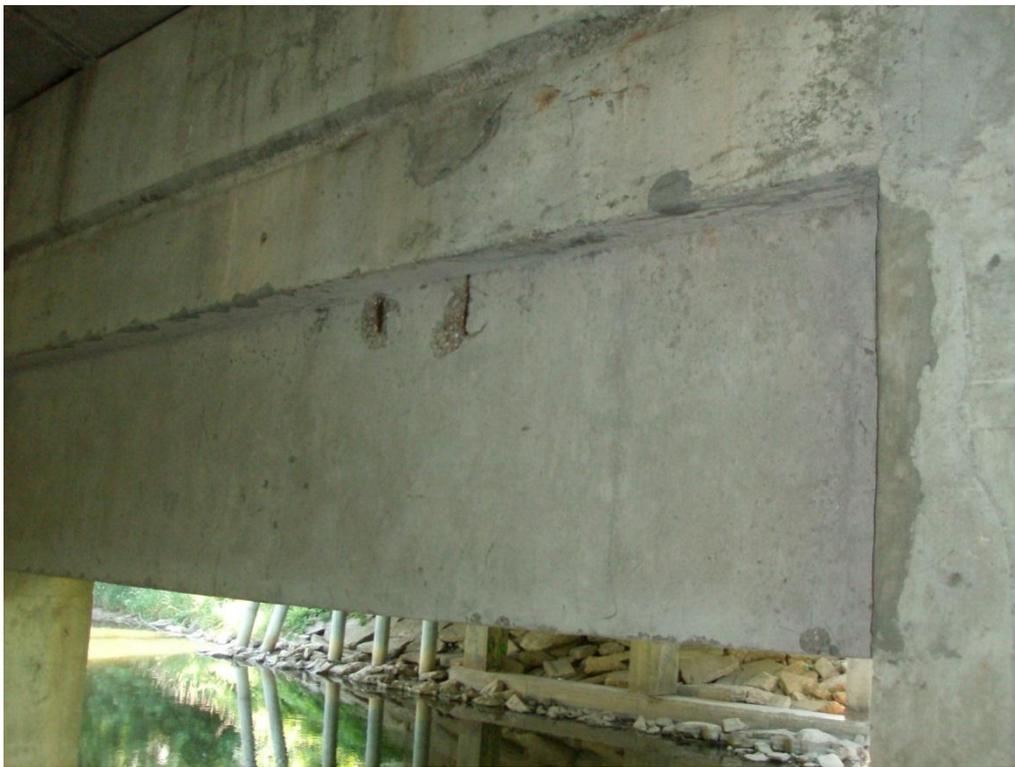
| 14. Piers SIA-60 | 7 | 7 | 6 | Original piers are concrete. Widened piers are galvanized pile bend with concrete pile cap. Minor spalling at the bottom at the north end of west pier. Minor spalling and delamination at centerline of w. pier. Minor delamination at south end of east pier. At 5th and 13th beam from south fascia minor spalling at bearing of east pier. Piers have sheet pile protection visible below the waterline. (12) Original piers are concrete. Widened piers are galvanized pile bend with concrete pile cap. Minor spalling at the bottom at the north end of west pier. Minor spalling and delamination at centerline of w. pier. Minor delamination at south end of east pier. At 5 and 13 beam from south fascia minor spalling at bearing of east pier. Piers have sheet pile protection visible below the water line. (10) Minor spalling at the bottom at the north end of west pier. Minor spalling and delamination at centerline of w. pier. Minor delamination at south end of east pier. At 5 and 13 beam from south fascia minor spalling at bearing of east pier. (08) |

Spalling on Pier Cap

| <u>WORK ACTIVITY</u> | | <u>QUANTITY</u> | <u>UNIT</u> | <u>UNIT COST</u> | <u>TOTAL</u> |
|---|---|---|---|---|---|
| Pier repair over water | (measured x 2) | 60.0 | CFT | \$225.00 /CFT | \$13,500 |
